The Open Civil Engineering Journal, 2017, 11, (Suppl-5, M6) 1106-1121

# Seismic Vulnerability and Damage Speedy Estimation of an Urban Sector within the Municipality of San Potito Sannitico (Caserta, Italy)

Antonio Formisano<sup>1,\*</sup>, Nicola Chieffo<sup>2</sup> and Marius Mosoarca<sup>2</sup><sup>1</sup>*Department of Structures for Engineering and Architecture, University of Naples Federico II, Piazzale Tecchio 80, Naples, Italy*<sup>2</sup>*Politehnica University of Timisoara, Str. Traian Lalescu, Timisoara, Romania*

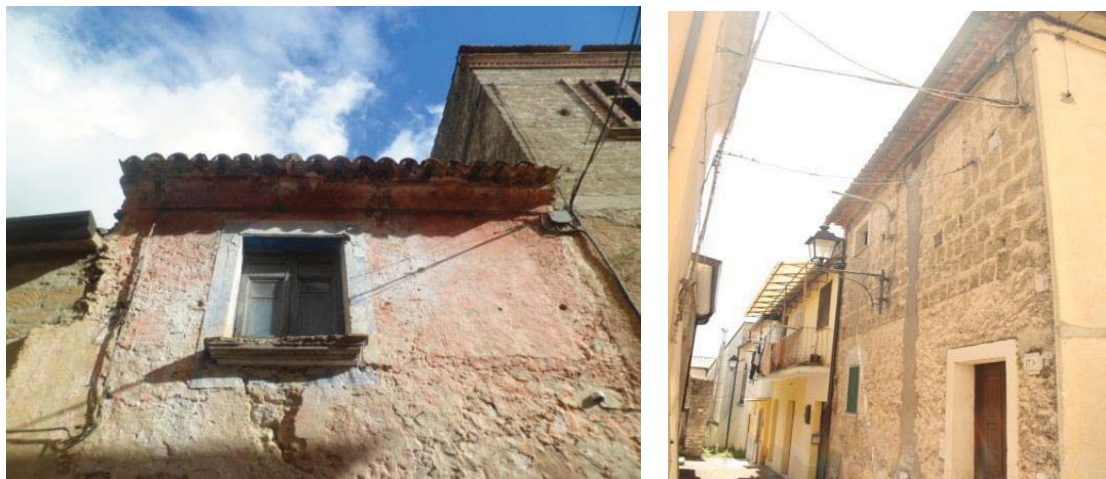
The survey carried out showed that the urban centre of the municipality of *San Potito Sannitico* is characterized by predominantly masonry buildings, whose constructions has followed a natural process of building aggregation, sometimes incongruous, whose stratifications and changes manifest themselves, in many cases, levels of seismic vulnerability not negligible.

**Fig. (8).** Inhomogeneity of masonry materials.

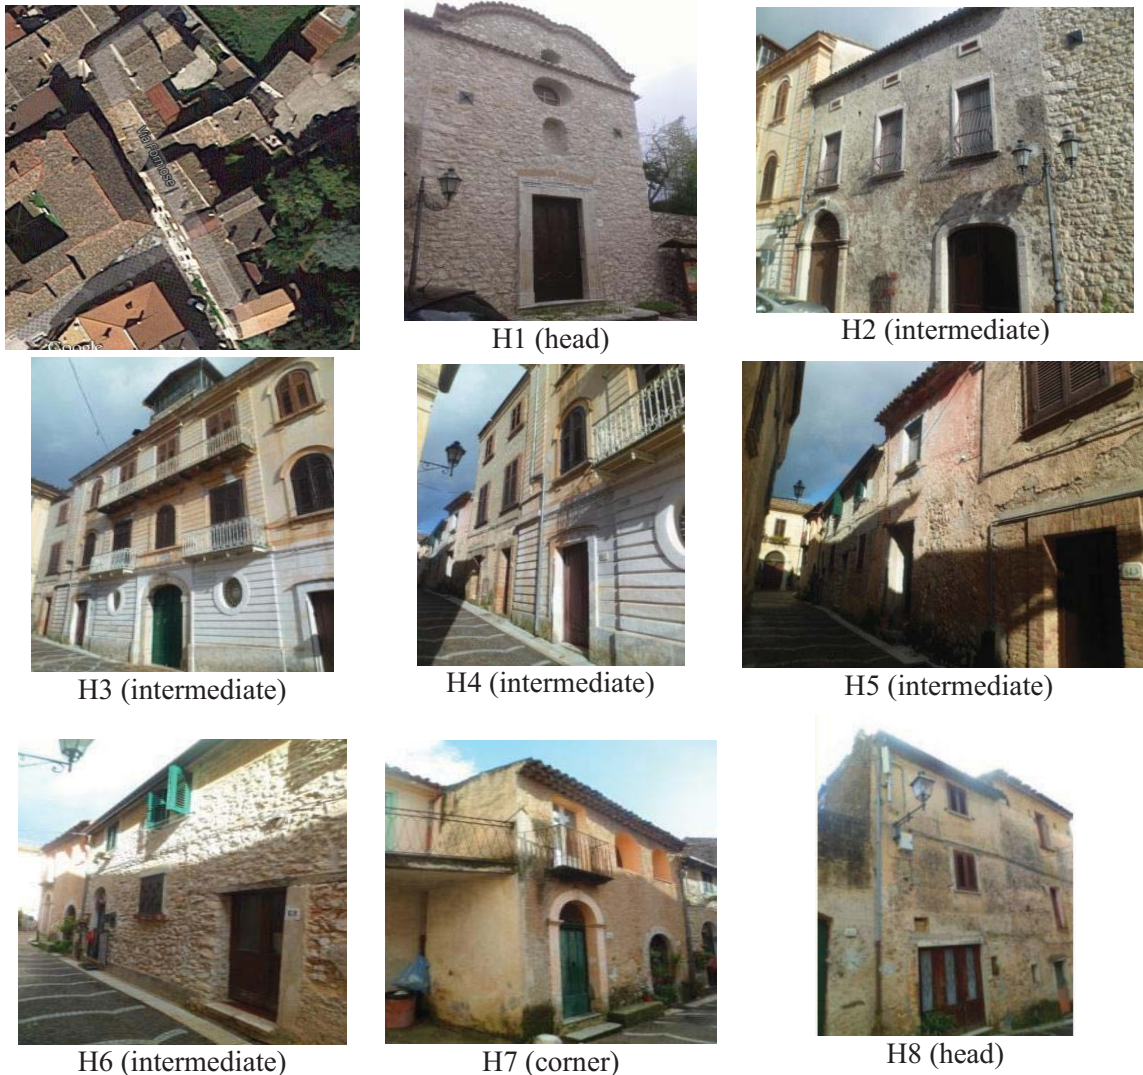
In the case under study, the quick methodology has been applied to all the building compounds, but, for the sake of example, only the aggregate *H* has been examined in detail. It is organised into eight structural units shown in Fig. (11), which are interconnected by means of common walls. They have a material inhomogeneity due to different construction techniques that characterised the town over the years.

**Fig. (11).** Structural Units of the aggregate *H*.

The S.U. have also irregularities in elevation, as well as they show the presence of staggered floors due to the different inter-storey height of S.U. belonging to the same aggregate.

The structural units H1, H3 and H4 are buildings of historical interest, which show a good preservation state. The other structural units composing the aggregate are made of ancient structures with obvious degradation signs. The vertical structures are made of squared stones held together by means of binder with poor mechanical characteristics. The horizontal structures do not guarantee an adequate in-plane stiffness and they often are made up of either timber members or steel ones.
